**Flood Control Project Maintenance  
Levee Inspections**  
**LMA District Cover Sheet**  
**Spring 2018 Levee Inspection Results**

**Reclamation District No. 2092 Dos Rios**

**Levee Inspection Report By Mile - Spring 2018**

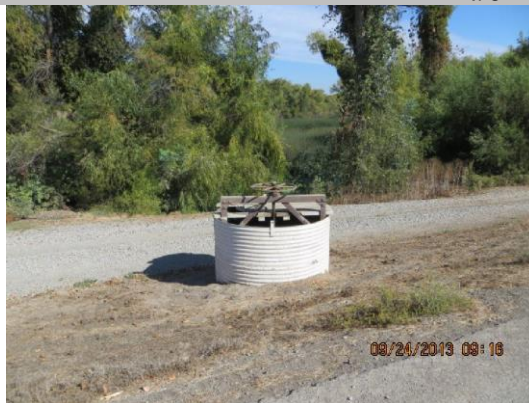
Photo 1 of 3 : UCIP\_SP\_2018\_27123\_50242.jpg

LM Start	0.18	Rating **	M	Issue No.	973
LM End	0.18	Issue Type +	Ma	Location *	
Category	Supplemental			GPS Latitude/Longitude	
				Start	End
Item	DWR UCIP LMA Responsibility			37.602031 °	37.602031 °
				-121.161249 °	-121.161249 °
DWR ID					
Comment Code					
Inspector Comment					
FS_ID:27123 DS_ID:20561 EP_NO: N/A Repair Type: Non-Urgent Crossing Status: Found UCIP Comments: Pipe rusted through at headwall on LS toe. Good candidate for video inspection. FIELD_STRUCT_DESC: 60-inch corrugated metal drainage pipe through the levee, 19 feet below the crown. Flap gate on the waterside (WS) end. Slide gate in an 80-inch corrugated metal pipe (CMP) riser on the WS slope. Concrete U-shaped headwalls on both ends. [Additional Reference(s): DWR Levee Log, 2005. USACE San Joaquin O&M Manual 5, August 1961, (HLM 0.18)]. FS Date: 1/16/2014 12:03:14 PM

Slide gate in 80-inch CMP riser on WS slope.

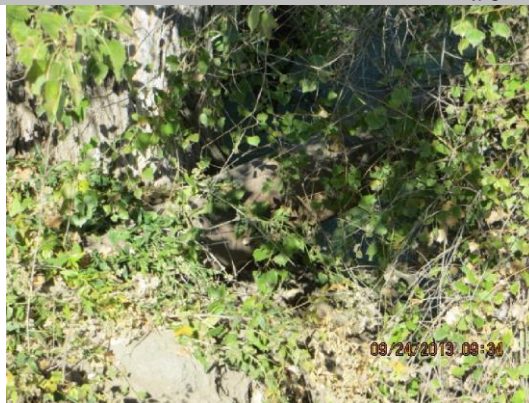
Comment Code						
Inspector Comment						
FS_ID:20885						
DS_ID:20579						
EP_NO: 6254						
Repair Type: Non-Urgent						
Crossing Status: Found						
UCIP Comments: Verify pipe has bee removed from levee. Pipe visible on WS at riverbank.						
FIELD_STRUCT_DESC: *ABANDONED* 16-inch steel drainage pipe over the levee with 3.5 feet of the fill on the top. Siphon breakers on the waterside (WS) shoulder. Pad constructed over pipes. This pumping plant was constructed in 1969 during emergency conditions without a permit. (Permit No. 6254, 1968 - John and Robert Bogetti). [Additional Reference(s): DWR Levee Log, 2005].						
FS Date: 9/24/2013

Pipe visible at rivers edge on WS toe.

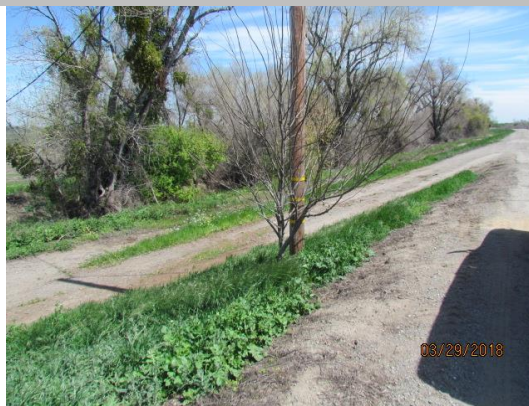
Photo 1 of 1 : SP\_2018\_RD2092\_116\_31\_20180330\_00047.jpg

Looking upstream at small tree on waterward should next to pole.  
(Spring 2018)

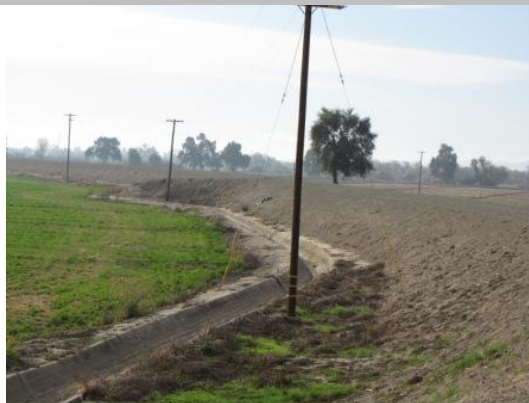
Photo 1 of 1 : SP\_2018\_RD2092\_116\_968\_20180307\_00008.jpg

View of agricultural ditch at the landward toe looking upstream.

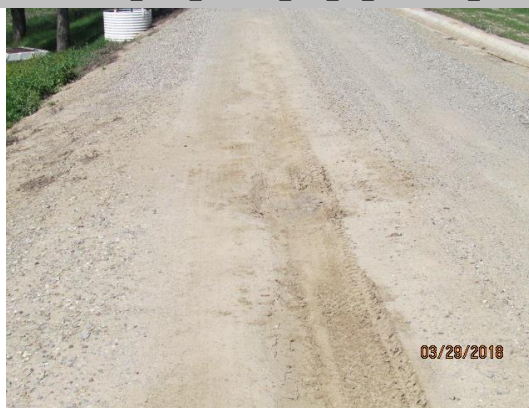
Photo 1 of 1 : SP\_2018\_RD2092\_116\_39\_20180330\_00045.jpg

LM Start	1.29	Rating **	M	Issue No.	39
LM End	1.31	Issue Type +	Ma	Location *	CR
Category	Earthen Levee			GPS Latitude/Longitude	
				Start	End
Item	Crown Surface / Depressions / Rutting			37.590701 °	37.590524 °
				-121.164339 °	-121.163947 °
DWR ID	DWR_RD2092_01_s_2017_39				
Comment Code					
C3 : Add appropriate gravel or road base. Grade and compact.					
Inspector Comment

Looking upstream at rutting and depression on levee crown. (Spring 2018)

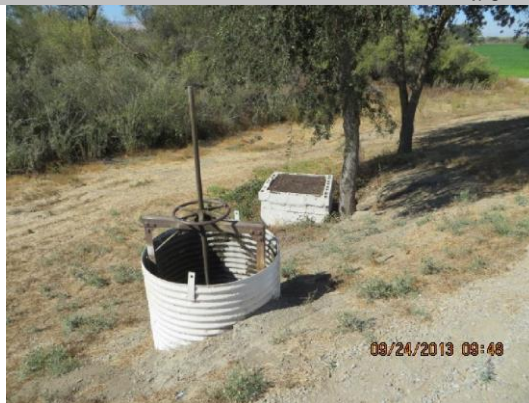
LM Start	1.30	Rating **	A/W	Issue No.	976
LM End	1.30	Issue Type +	Ma	Location *	
Category	Supplemental			GPS Latitude/Longitude	
				Start	End
Item	DWR UCIP LMA Responsibility			37.590603 °	37.590603 °
				-121.164111 °	-121.164111 °
DWR ID					
Comment Code					
Inspector Comment					
FS_ID:20889 DS_ID:20562 EP_NO: N/A Repair Type: No Action Needed Crossing Status: Found UCIP Comments: FIELD_STRUCT_DESC: 36-inch corrugated metal drainage pipe through the levee, 15 feet below the crown. Slide gate in a 48-inch corrugated metal pipe (CMP) riser on the waterside (WS) slope. 4-foot by 6-foot concrete distribution box on the landside (LS) toe. 5-foot by 5-foot concrete riser on the WS toe. [Additional Reference(s): DWR Levee Log, 2005. USACE San Joaquin O&M Manual 5, August 1961, (HLM 1.31)]. FS Date: 9/24/2013

Slide gate in 48-inch CMP riser on WS slope.

Concrete distribution box at concrete canal on LS toe.

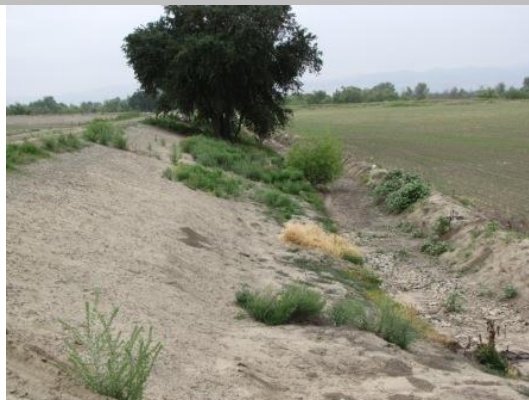
Photo 1 of 1 : SP\_2018\_RD2092\_116\_8\_20180307\_00001.jpg

View of an agricultural ditch at the waterward toe of the slope.

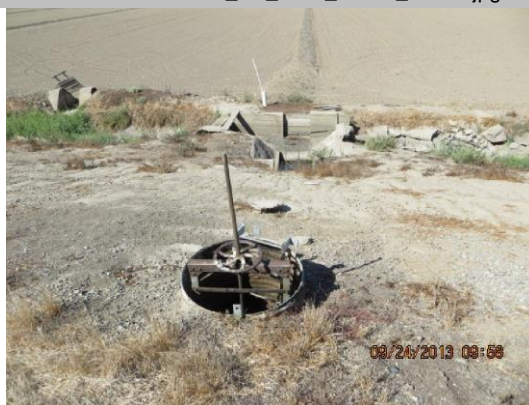
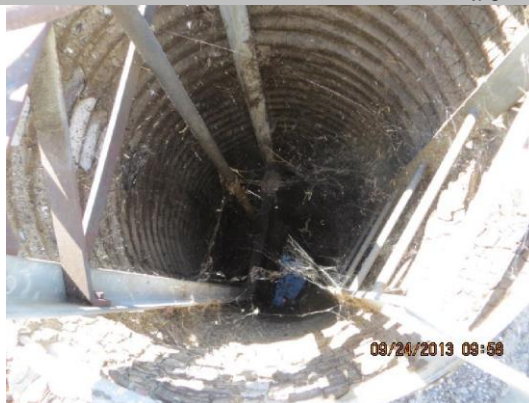
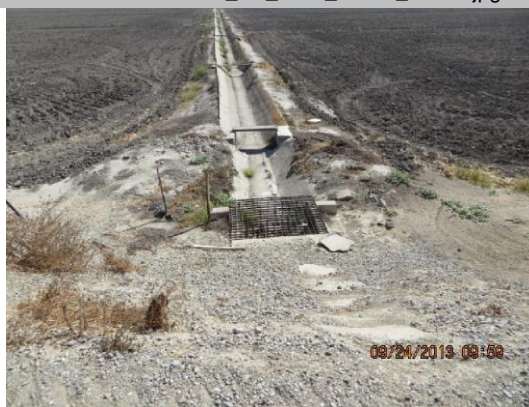
LM Start	1.69	Rating **	A/W	Issue No.	977
LM End	1.69	Issue Type +	Ma	Location *	
Category	Supplemental			GPS Latitude/Longitude	
				Start	End
Item	DWR UCIP LMA Responsibility			37.585938 °	37.585938 °
				-121.163348 °	-121.163348 °
DWR ID					
Comment Code					
Inspector Comment					
FS_ID:20891 DS_ID:20563 EP_NO: N/A Repair Type: No Action Needed Crossing Status: Found UCIP Comments: FIELD_STRUCT_DESC: 24-inch corrugated metal drainage pipe through the levee, 14 feet below the crown. Slide gate in a corrugated metal pipe (CMP) riser on the waterside (WS) slope. Concrete U-shaped headwall at the landside (LS) toe. [Additional Reference(s): DWR Levee Log, 2005. USACE San Joaquin O&M Manual 5, August 1961, (HLM 1.71)]. FS Date: 9/24/2013

Slide gate in 36-inch CMP riser on WS slope.

Concrete headwall at base of LS toe.

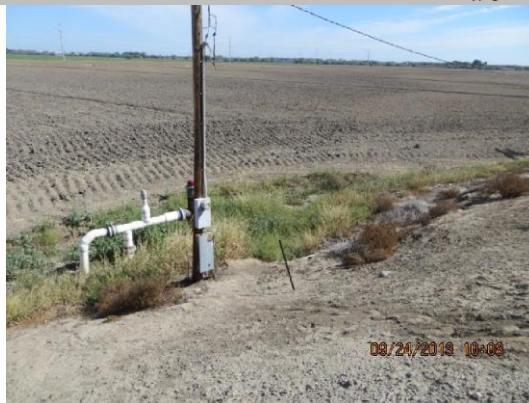
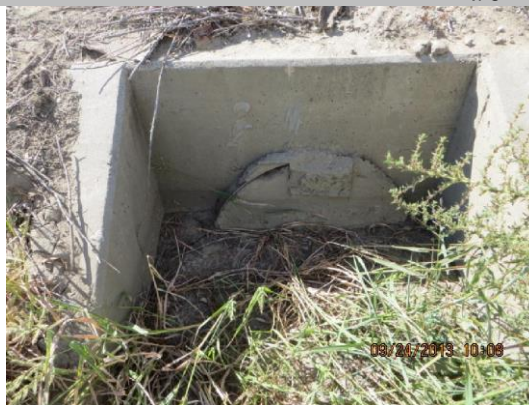
LM Start	2.07	Rating **	A/W	Issue No.	978
LM End	2.07	Issue Type +	Ma	Location *	
Category	Supplemental			GPS Latitude/Longitude	
				Start	End
Item	DWR UCIP LMA Responsibility			37.584212 °	37.584212 °
				-121.158347 °	-121.158347 °
DWR ID					
Comment Code					
Inspector Comment					
FS_ID:20904 DS_ID:20564 EP_NO: N/A Repair Type: No Action Needed Crossing Status: Found UCIP Comments: FIELD_STRUCT_DESC: *ABANDONED* 30-inch corrugated metal drainage pipe through the levee, 15 feet below the crown. Flap gate on the waterside (WS) end. Concrete U-shaped headwalls on both ends. Filled with concrete on the landside (LS) toe. [Additional Reference(s): DWR Levee Log, 2005. USACE San Joaquin O&M Manual 5, August 1961, (HLM 2.10), 36-inch pipe listed]. FS Date: 9/24/2013

Pipe and concrete headwall visible on LS toe to right of powerpole.

Pipe and concrete headwall visible on LS toe.

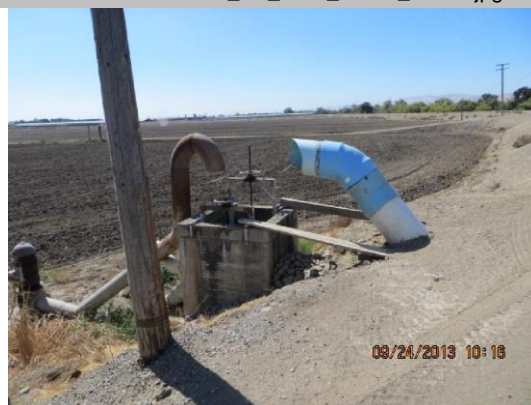
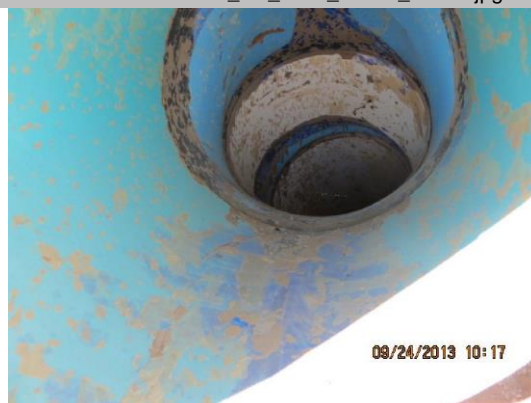
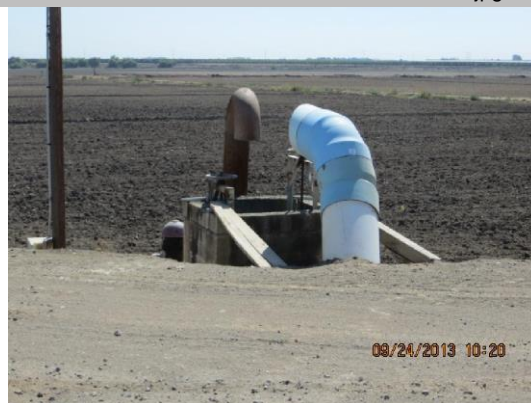
LM Start	2.34	Rating **	M	Issue No.	979	
LM End	2.34	Issue Type +	En	Location *		
Category	Supplemental			GPS Latitude/Longitude		
				Start	End	
Item	DWR UCIP Field Study			37.581226 °	37.581226 °	
				-121.156175 °	-121.156175 °	
DWR ID						
Comment Code						
Inspector Comment						
FS_ID:22916 DS_ID:24680 EP_NO: N/A Repair Type: Non-Urgent Crossing Status: Found UCIP Comments: No permit identified for this crossing. FIELD_STRUCT_DESC: 21-inch polyvinyl chloride (PVC) irrigation pipe through the levee, at an unknown depth. Pipe discharges into a concrete distribution box on the landside (LS) toe. Pump on pier off the waterside (WS) toe. [Additional Reference(s): DWR Levee Log, 2005]. FS Date: 9/24/2013

21-inch PVC irrigation pipe visible on LS shoulder.

Inside of pipe at LS shoulder.

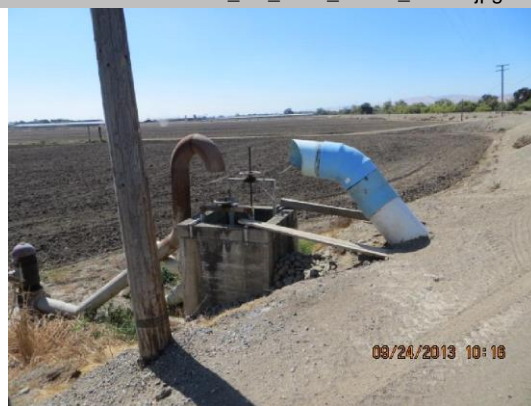
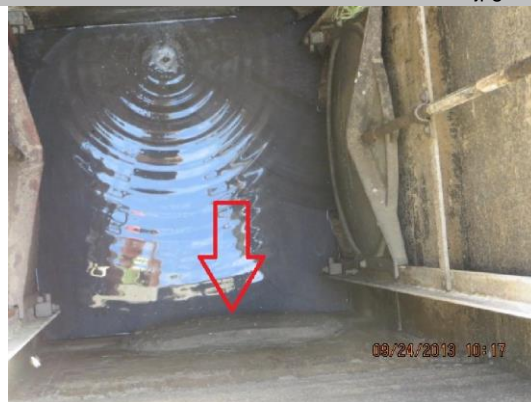
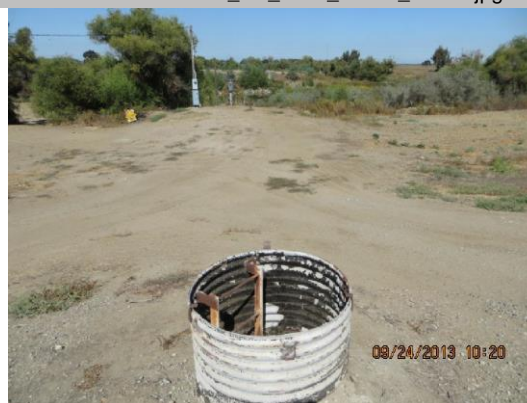
Comment Code					
Inspector Comment					
FS_ID:20908 DS_ID:20566 EP_NO: N/A Repair Type: Non-Urgent Crossing Status: Found UCIP Comments: Pipe appears abandoned and needs to be verified as having been done so properly. FIELD_STRUCT_DESC: *ABANDONED* 24-inch corrugated metal irrigation pipe through the levee, 11 feet below the crown. Slide gate in a 36-inch corrugated metal pipe (CMP) riser on the waterside (WS) slope. 5-foot by 5-foot concrete distribution box on the landside (LS). Pump on platform in the channel. Pipe filled with concrete on the LS toe. [Additional Reference(s): DWR Levee Log, 2005. USACE San Joaquin O&M Manual 5, August 1961, (HLM 2.38)]. FS Date: 9/24/2013

5x5 concrete distribuion box on LS toe.

Pipe filled with concrete inside conc. distro box on LS toe.

36-inch CMP riser on WS slope.

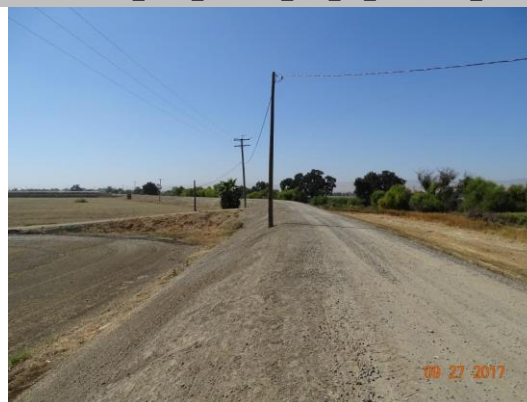
Photo 1 of 1 : SP\_2018\_RD2092\_116\_20\_20180307\_00004.jpg

LM Start	2.37	Rating **	M	Issue No.	20
LM End	2.37	Issue Type +	En	Location *	LS
Category	Earthen Levee			GPS Latitude/Longitude	
				Start	End
Item	Encroachments			37.580821 °	37.580821 °
				-121.156468 °	-121.156468 °
DWR ID	DWR_RD2092_01_f_2014_20				
Comment Code					
PO : Pole					
Inspector Comment

View of the pole on the landside slope of the levee looking upstream.

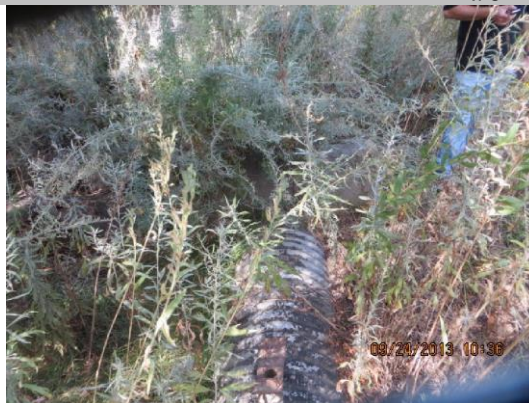
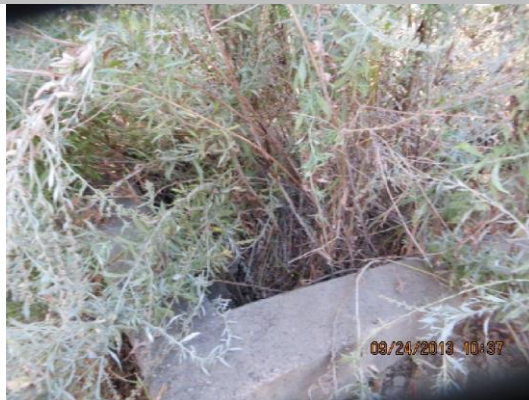
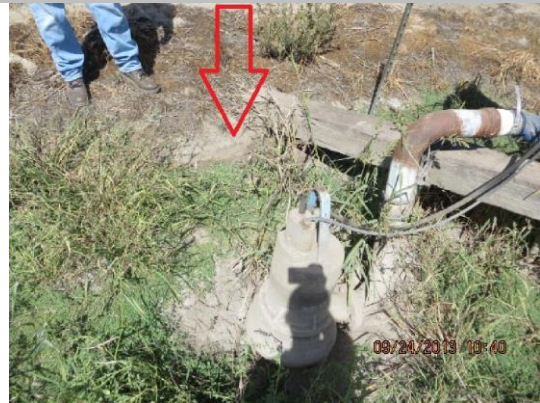
LM Start	2.40	Rating **	M	Issue No.	981	
LM End	2.40	Issue Type +	Ma	Location *		
Category	Supplemental			GPS Latitude/Longitude		
				Start		End
Item	DWR UCIP LMA Responsibility			37.580426 °	37.580426 °	
				-121.156798 °	-121.156798 °	
DWR ID						
Comment Code						
Inspector Comment						
FS_ID:20943 DS_ID:20567 EP_NO: N/A Repair Type: Non-Urgent Crossing Status: Found UCIP Comments: Appears abandoned and if so should be done so properly. FIELD_STRUCT_DESC: *ABANDONED* 24-inch corrugated metal drainage pipe through the levee, 15 feet below the crown. Flap gate on the waterside (WS) end. Concrete U-shaped headwall on the WS end. Concrete headwall on the landside (LS) toe next to pump. [Additional Reference(s): DWR Levee Log, 2005. USACE San Joaquin O&M Manual 5, August 1961, (HLM 2.44)]. FS Date: 9/24/2013

24-inch pipe visible on WS berm.

Concrete U-shaped headwall and flapgate on WS berm.

Concrete headwall next to pump on WS toe.

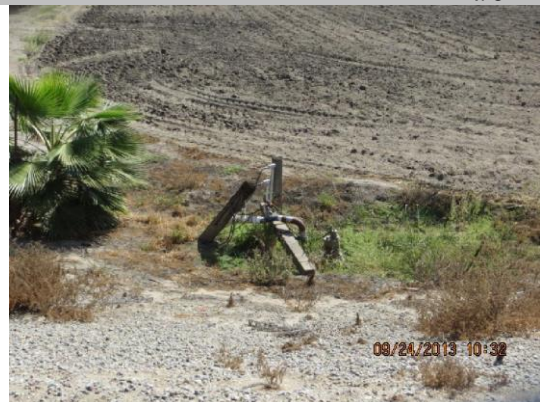
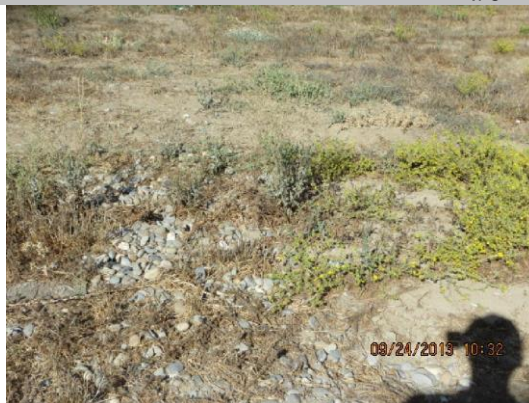
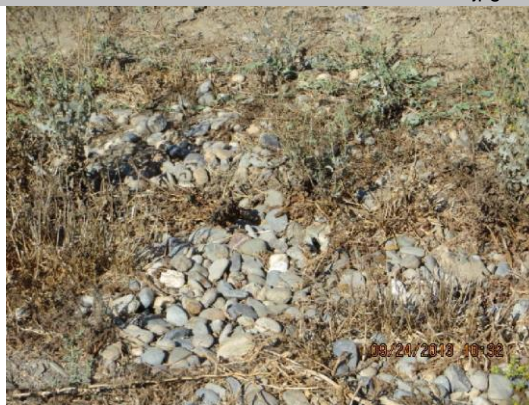
LM Start	2.41	Rating **	M	Issue No.	982
LM End	2.41	Issue Type +	En	Location *	
Category	Supplemental			GPS Latitude/Longitude	
				Start	End
Item	DWR UCIP Field Study			37.580405 °	37.580405 °
				-121.156825 °	-121.156825 °
DWR ID					
Comment Code					
Inspector Comment					
FS_ID:20923					
DS_ID:20568					
EP_NO: N/A					
Repair Type: Non-Urgent					
Crossing Status: Indicator Found					
UCIP Comments: Pipe abandoned and should be verified as having been removed from the levee.					
FIELD_STRUCT_DESC: *ABANDONED* 4-inch drainage pipe of an unknown material through the levee, 1 foot below the crown. Pump on sump at the landside (LS) toe. Roadway extending to the LS pump.					
[Additional Reference(s): DWR Levee Log, 2005].					
FS Date: 9/24/2013

Pump and 4-inch pipe visible at LS toe.

Gravel on WS slope appears to indicate trench.

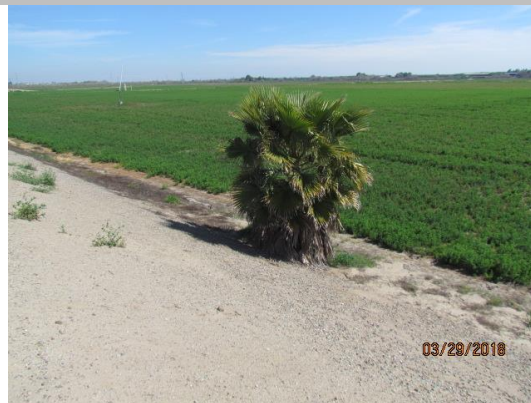
Photo 1 of 1 : SP\_2018\_RD2092\_116\_19\_20180330\_00044.jpg

Looking at Palm tree at landward toe. (Spring 2018)

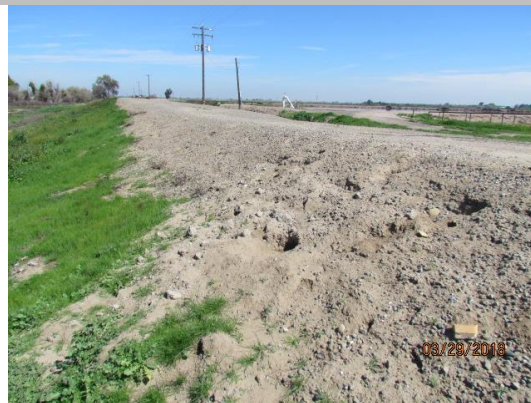
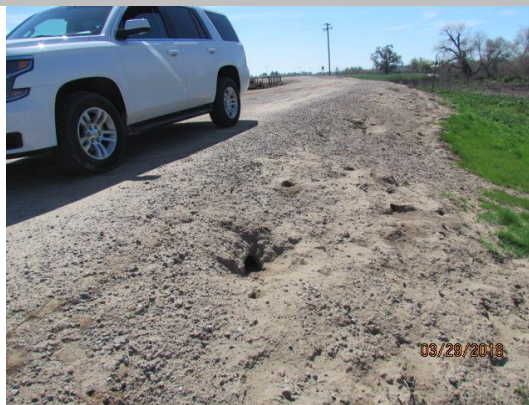
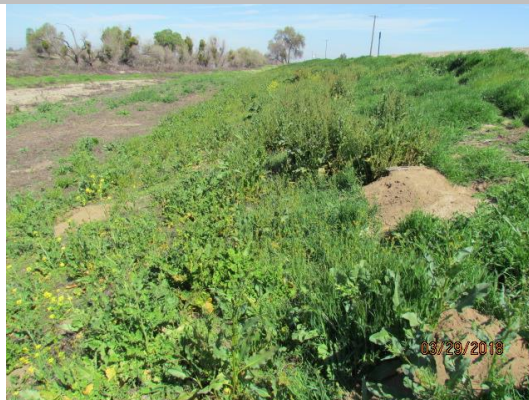
Looking upstream on waterward slope at several large rodent holes. (Spring 2018)

Looking at typical large rodent holes on waterward slope. (Spring 2018)

Looking downstream at several rodent holes on waterward slope. (Spring 2018)

Looking upstream at large rodent holes on waterward slope. (Spring 2018)

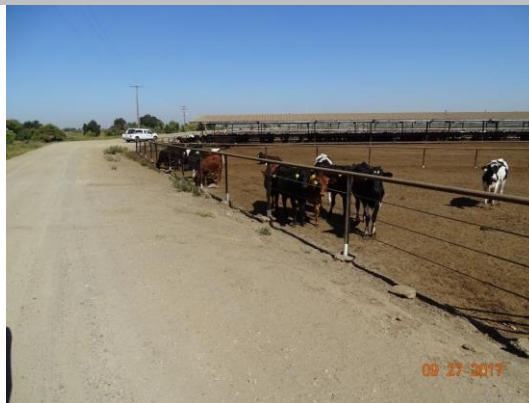
Photo 1 of 1 : SP\_2018\_RD2092\_116\_27\_20180307\_00005.jpg

View of a fence on the landside toe of the levee looking downstream.

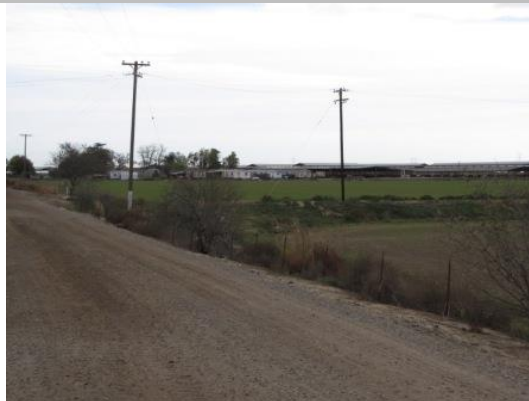
Photo 1 of 1 : SP\_2018\_RD2092\_116\_972\_20180307\_00009.jpg

View of barbed wire fence along the waterward slope looking upstream.

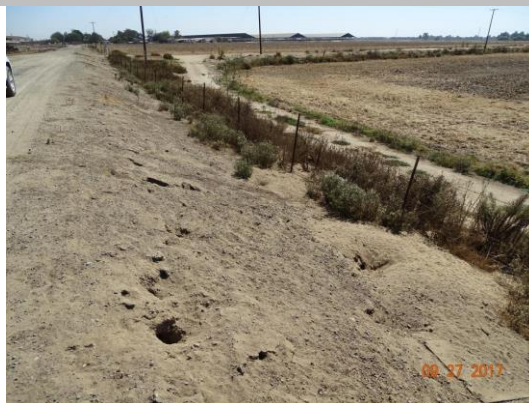
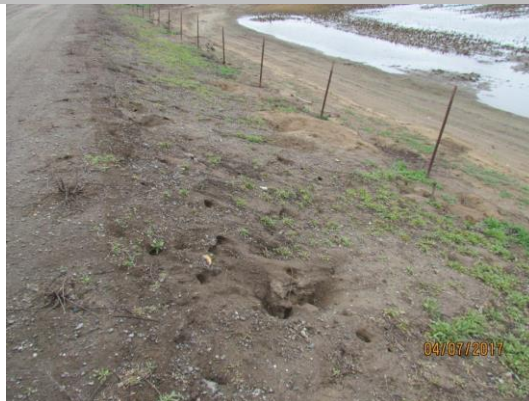
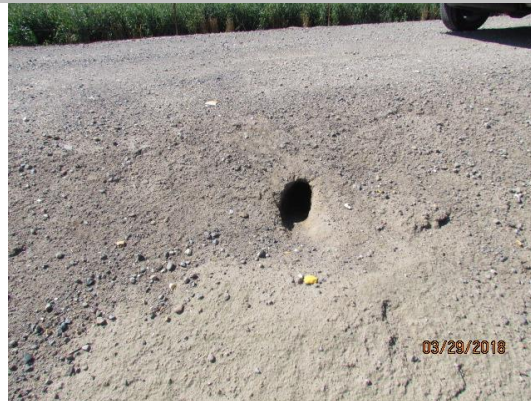
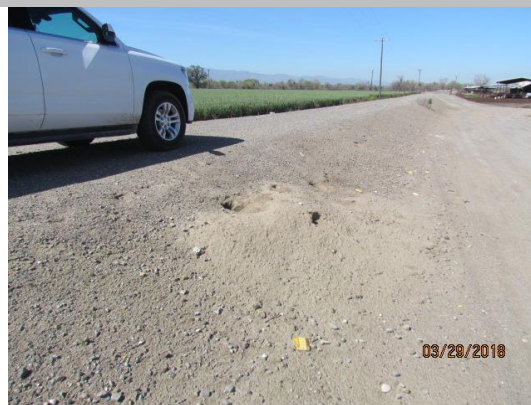
Updated picture of the rodent holes on the waterside of the levee looking upstream. Fall 2017

View of multiple rodent holes on the waterside slope of the levee. Spring 2017

Looking at Typical view of rodent holes on landward sloop within this reach. (Spring 2018)

Looking upstream at several rodent holes on landward slope. (Spring 2018)

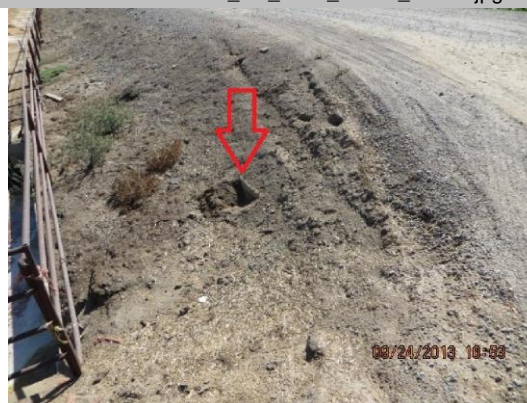
Photo 1 of 1 : UCIP\_SP\_2018\_20944\_35255.jpg

LM Start	2.86	Rating **	M	Issue No.	983
LM End	2.86	Issue Type +	En	Location *	
Category	Supplemental			GPS Latitude/Longitude	
				Start	End
Item	DWR UCIP Field Study			37.574741 °	37.574741 °
				-121.155495 °	-121.155495 °
DWR ID					
Comment Code					
Inspector Comment					
FS_ID:20944 DS_ID:20570 EP_NO: N/A Repair Type: Non-Urgent Crossing Status: Indicator Found UCIP Comments: Appears abandoned and if so, should be done so properly. FIELD_STRUCT_DESC: *ABANDONED* 24-inch corrugated metal drainage pipe through the levee, 6.5 feet below the crown. Concrete U-shaped headwall and flap gate on the waterside (WS) end. Concrete headwall on the landside (LS) slope. [Additional Reference(s): DWR Levee Log, 2005. USACE San Joaquin O&M Manual 5, August 1961]. FS Date: 9/24/2013

Concrete headwall visible on LS slope.

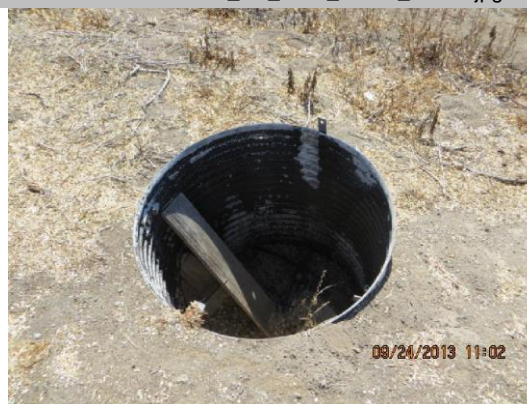
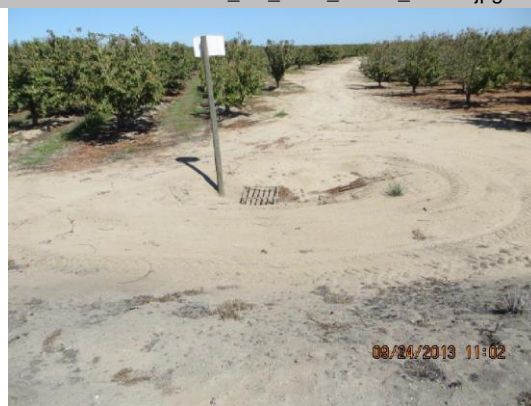
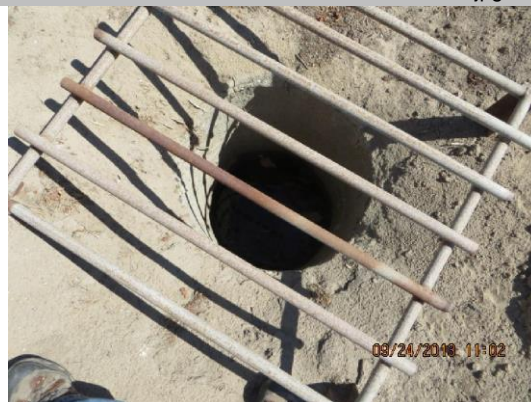
LM Start	3.47	Rating **	M	Issue No.	984
LM End	3.47	Issue Type +	Ma	Location *	
Category	Supplemental			GPS Latitude/Longitude	
				Start	End
Item	DWR UCIP LMA Responsibility			37.573304 °	37.573304 °
				-121.144747 °	-121.144747 °
DWR ID					
Comment Code					
Inspector Comment					
FS_ID:20945 DS_ID:20572 EP_NO: N/A Repair Type: Non-Urgent Crossing Status: Found UCIP Comments: This pipe appears abandoned and if so, should be done so properly. FIELD_STRUCT_DESC: *ABANDONED* 36-inch corrugated metal drainage pipe through the levee, 11 feet below the crown. Slide gate in a corrugated metal pipe (CMP) riser on the waterside (WS) slope. Concrete headwalls on both ends. [Additional Reference(s): DWR Levee Log, 2005. USACE San Joaquin O&M Manual 5, August 1961, (HLM 3.52)]. FS Date: 9/24/2013

48-inch CMP riser on WS slope.

Grate over sump on LS toe.
